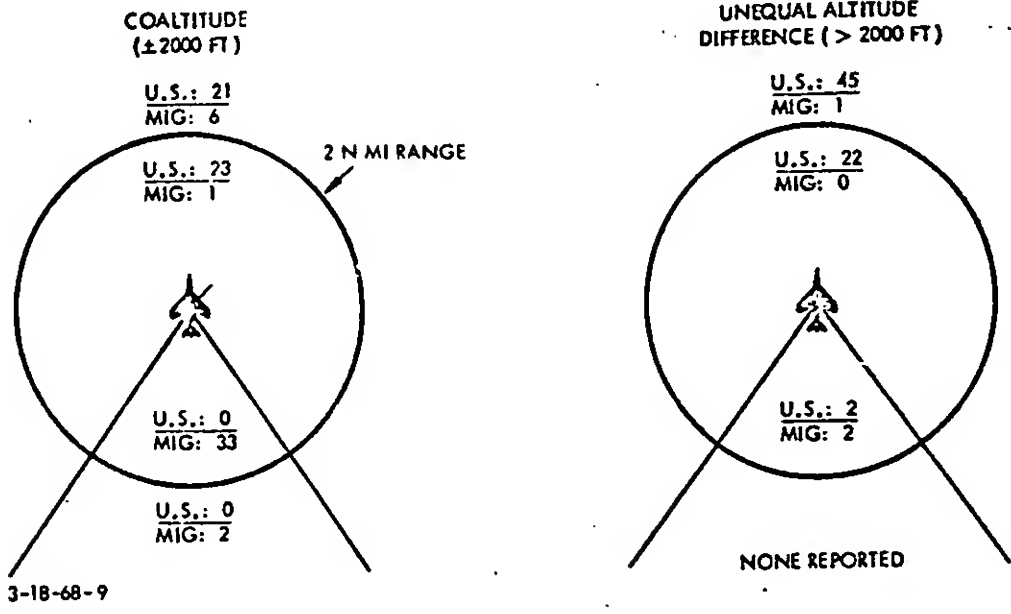
FIGURE III-B2 (S). Ratio of U.S. to MIG-17 First Firings for Different Acquisition Conditions (U)

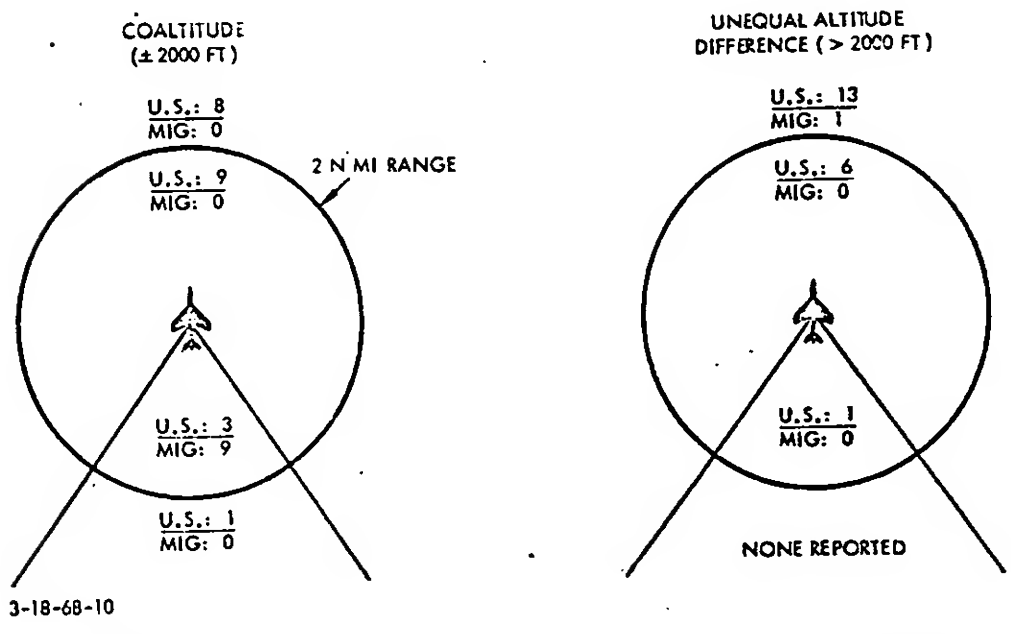
FIGURE III-B3 (S). Ratio of U.S. to MIG-21 First Firings for Different Acquisition Conditions (U)

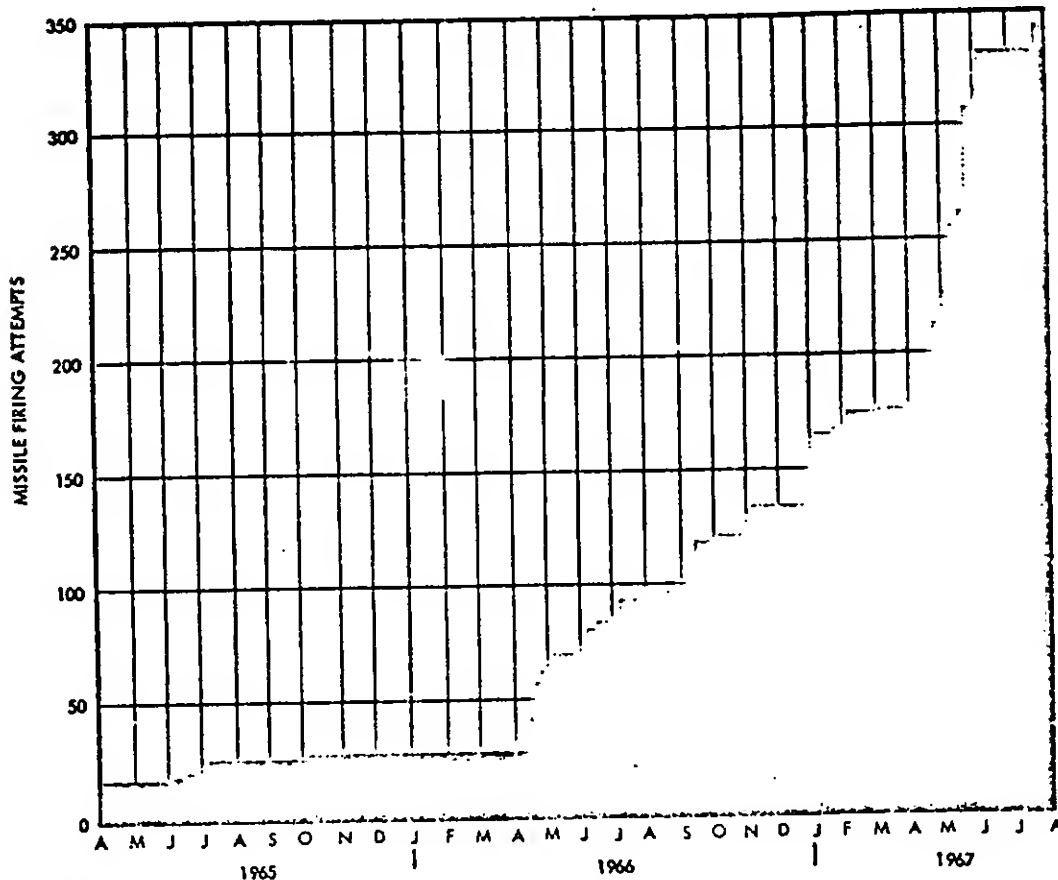
FIGURE III-C5 (S). AIM-7 Summary (U)

(S) The AIM-7D was employed in SEA from April 1965 through April 1966. The AIM-7E replaced the AIM-7D in April 1966 and has been used since that time. The summary of AIM-7 results is shown in Figure III-C5, while Figure III-C6 further subdivides the missile system failures. Note that the fraction of attempts fired out-of-envelope is small and that the fraction of prelaunch failures of the AIM-7D has been reduced. When considering the postlaunch results of the AIM-7E, the environment should be examined. Figure III-C7 combines a time-based histogram of AIM-7D and AIM-7E firing attempts (subdivided into hits, Missile System Failures, and other results) with a target maneuvering, non-maneuvering dichotomy

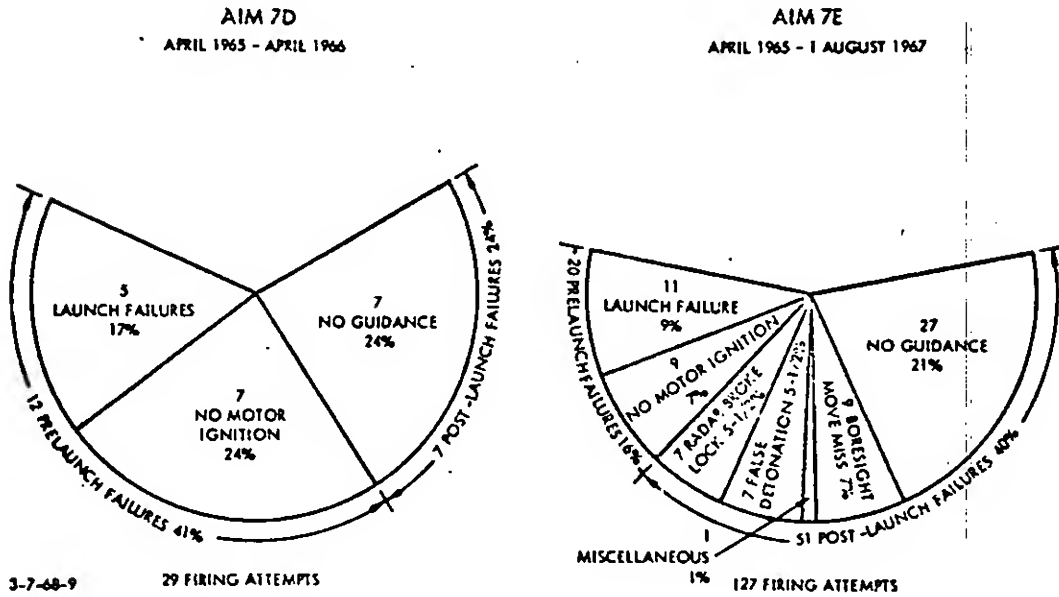
FIGURE III-C6 (S). AIM-7 Missile System Failures (U)

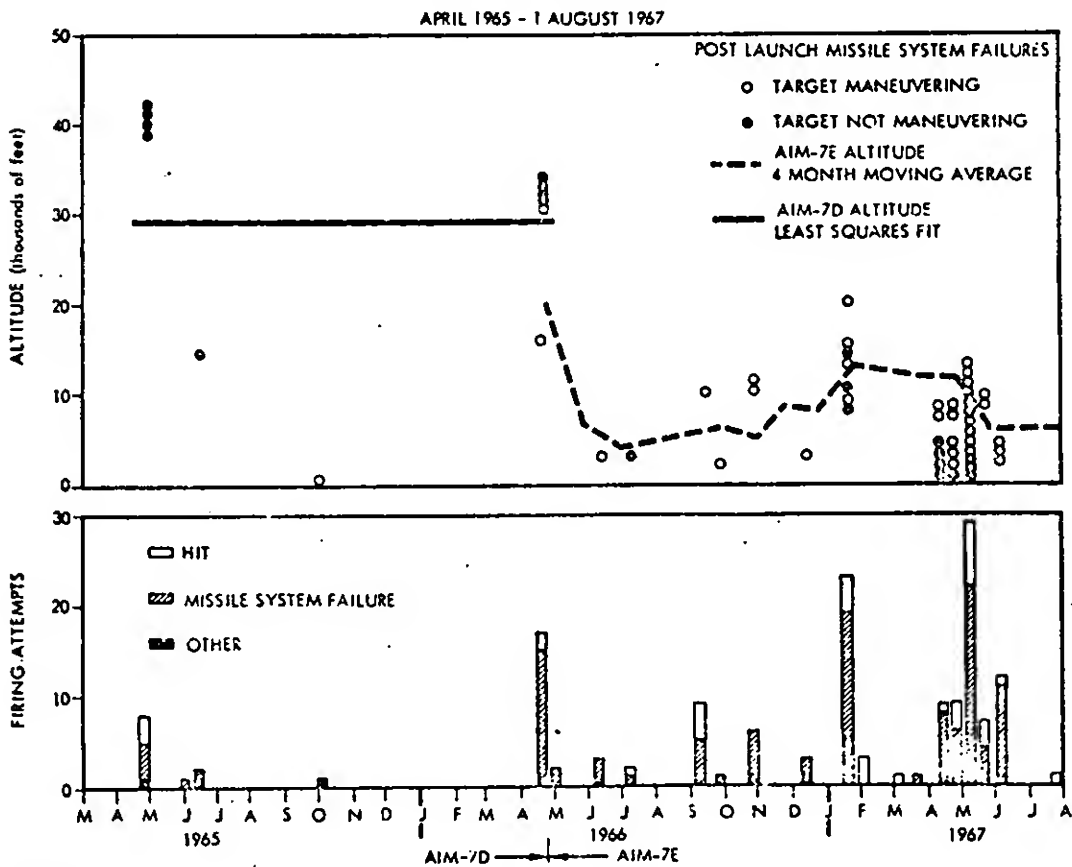
FIGURE III-C7 (S). History of AIM-7 Firing Attempts (U)

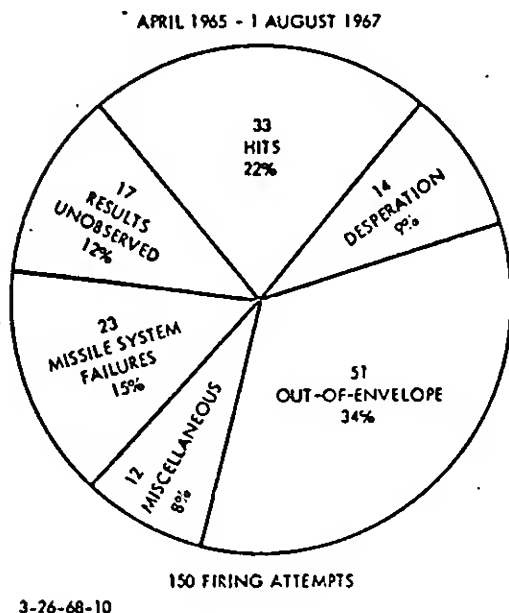
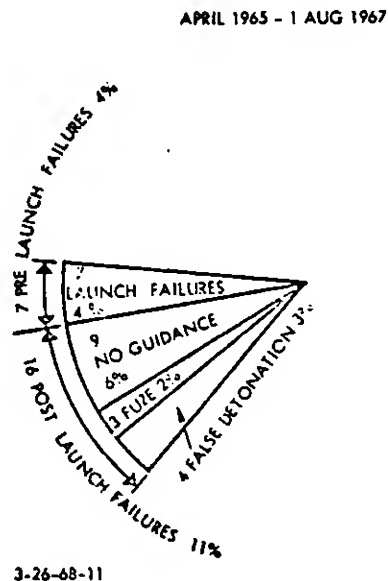
FIGURE III-C9 (S). AIM-9B Summary (U)

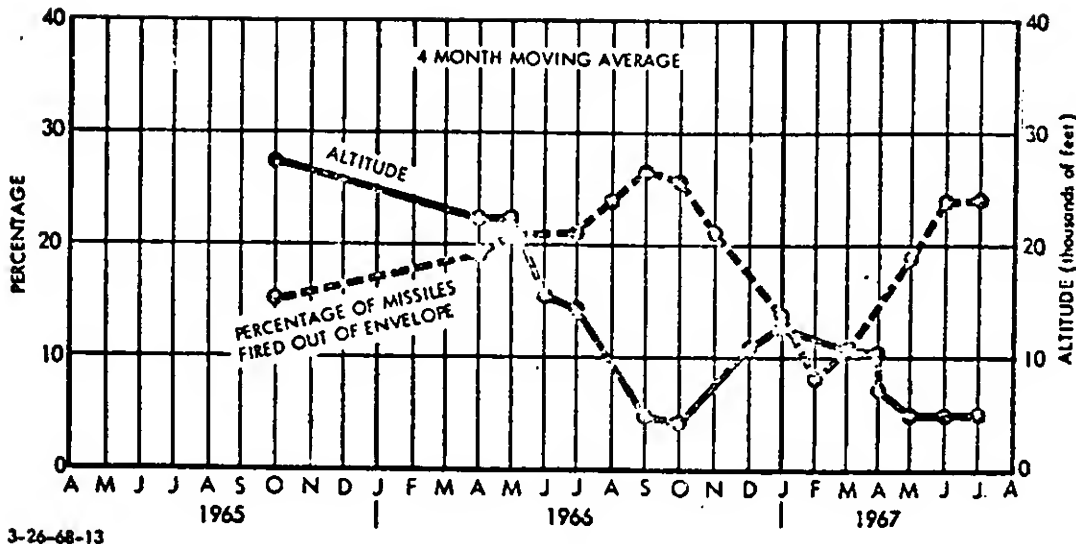
FIGURE III-C14 (S). Comparison of Altitude and Out-of-Envelope Ratio (U)

(S) There are a variety of contributing causes to the out-of-envelope phenomenon; among these are missile type, aircraft g's, target g's, and altitude at time of firing. Although less obvious, the effect of altitude on out-of-envelope firings becomes apparent by a comparison of envelopes at

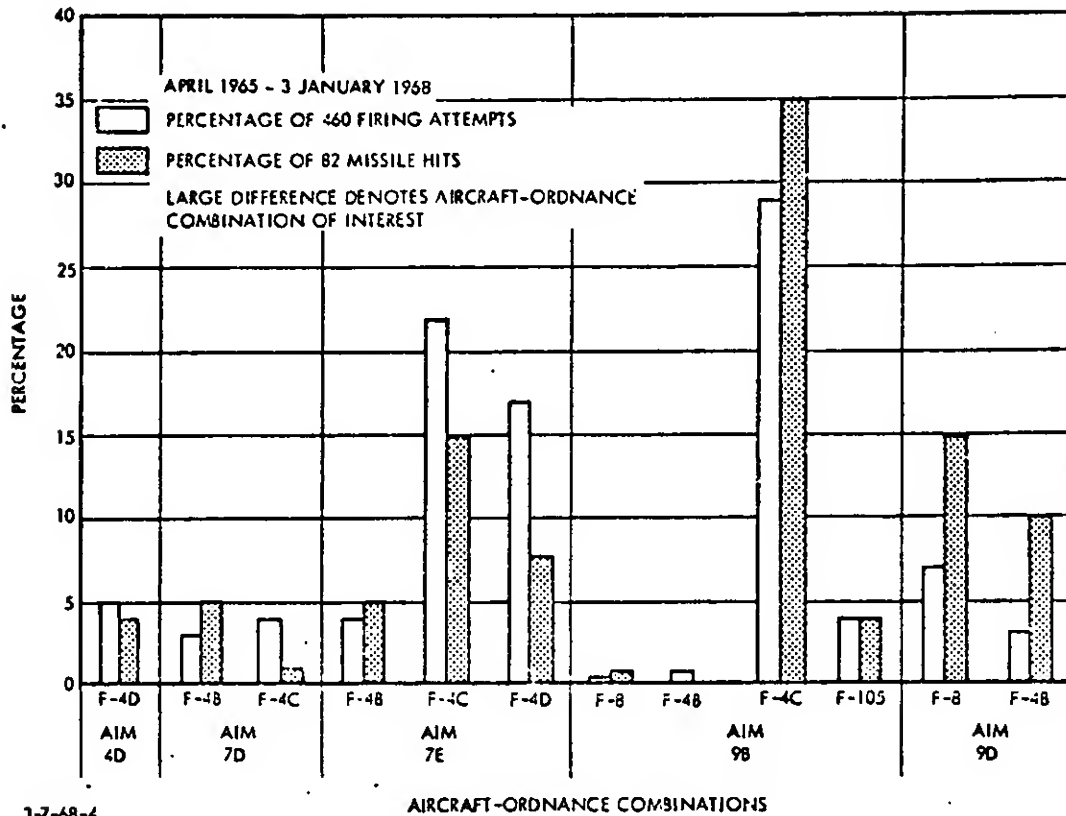
FIGURE III-C15 (S). Comparison of Aircraft-Ordnance Combinations for Percentage of Missile Hits (U)

(S) The desired result of a missile firing attempt is a target hit. In this sense all results in the other categories (with the possible exception of desperation firing) must be considered a nonsuccess. Figure III-C15 shows the percentage of firing attempts together with the percentage of hits for each aircraft-ordnance combination (data through 3 January 1968). Again the combinations are heterogenous (at the 2.6-sigma level). The AIM-9D hit ratio was significantly higher than that of the other missile types. No significant difference could be detected among the remaining missile types. (Note that the zero hits of the AIM-9B/F-4B do not negate this conclusion because the sample size is small).

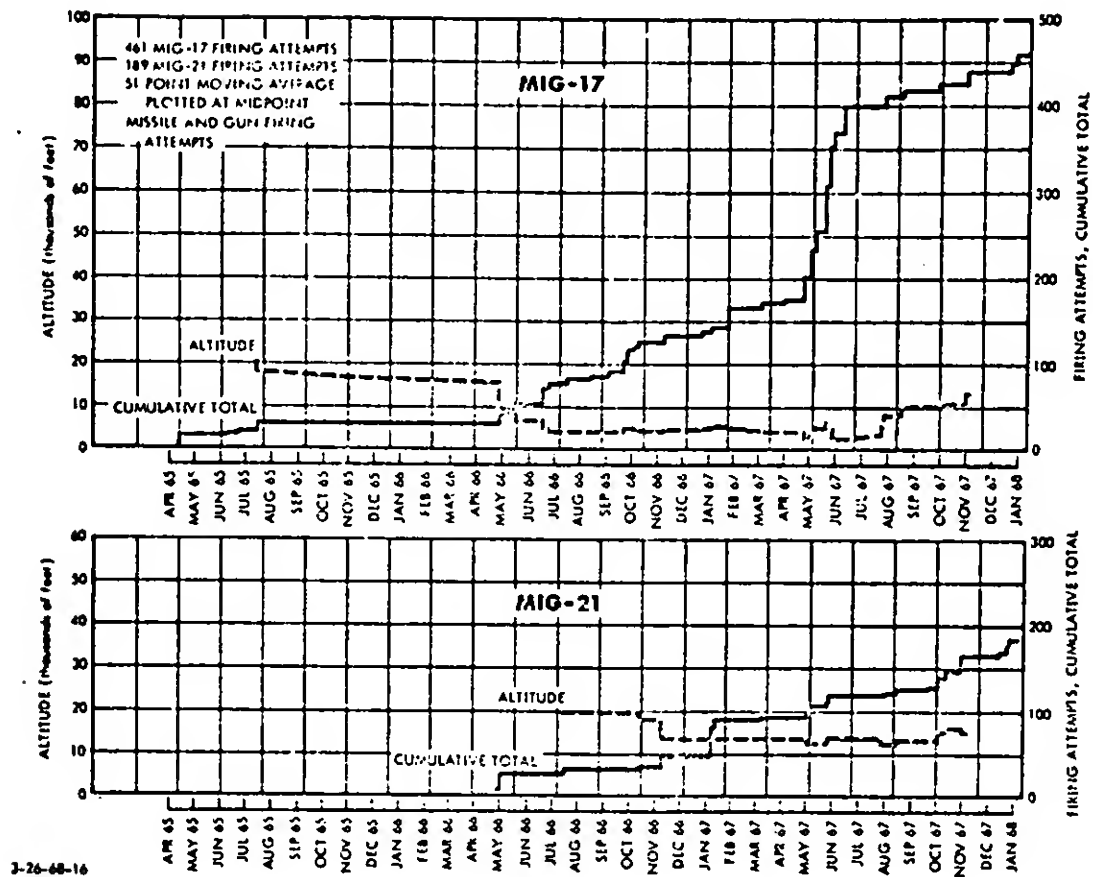
FIGURE III-C22 (S). Altitude of Firing Attempts by Target Type (U)

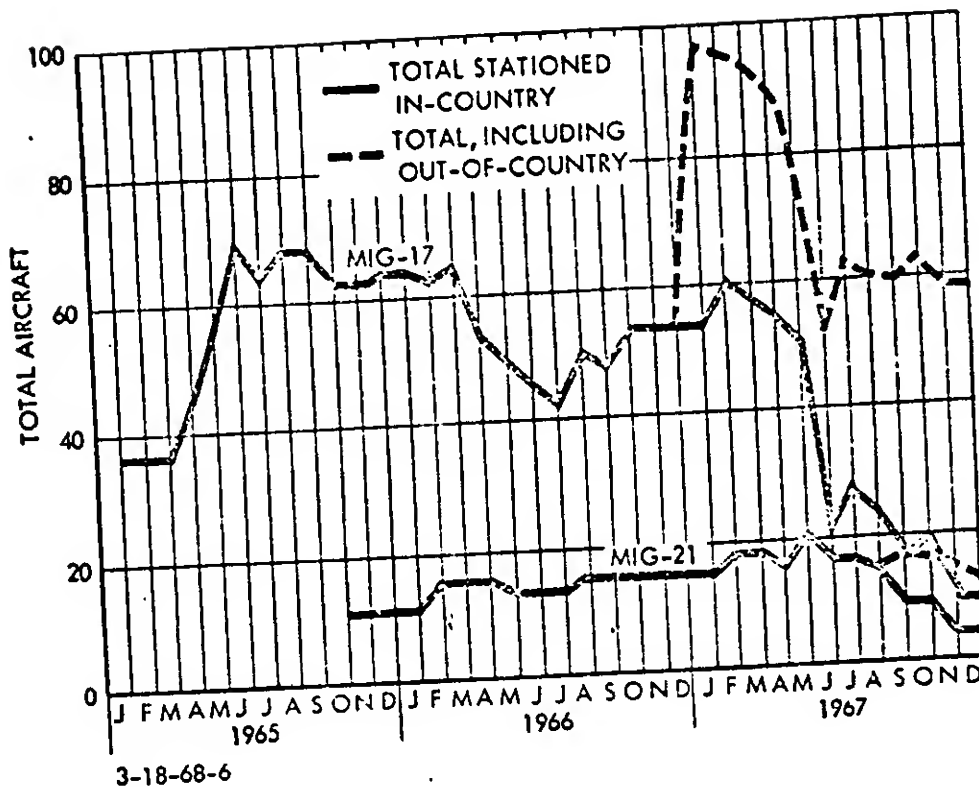
FIGURE A4 (SNF). MIG Order of Battle (U)
